uSmart3300 Nexgen

Disinfection and COVID-19 Pandemic info

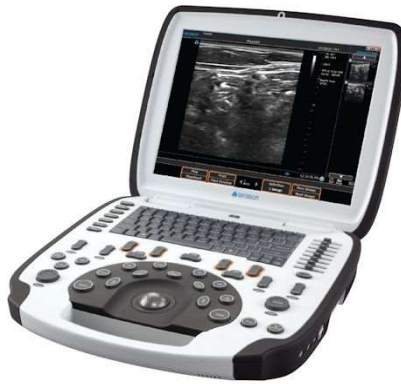
The Terason uSmart3300 Nexgen is a console computer-based ultrasound system. It is not a sealed system, so care must be taken to keep liquids and gels from entering the keys, buttons, and trackball. It is recommended that the system be wiped clean regularly with a soft cloth and Isopropyl alcohol. The body of the system is constructed of an ABS/PC plastic alloy. It is impact and wear resistant, but some chemical cleaners can affect the strength and performance of the plastic. Use of hospital cleaners and wipes should be avoided to maintain the strength of the system body and buttons. See volume 2 of the User Guide for complete and proper cleaning procedures.
